SCHOONER *C.A. Thayer*

Historic Structure Report 1991
DRAFT

San Francisco Maritime National Historical Park

Prepared by
Tri-Coastal Marine, Inc. 200
Burrows Street
San Francisco, CA 94134

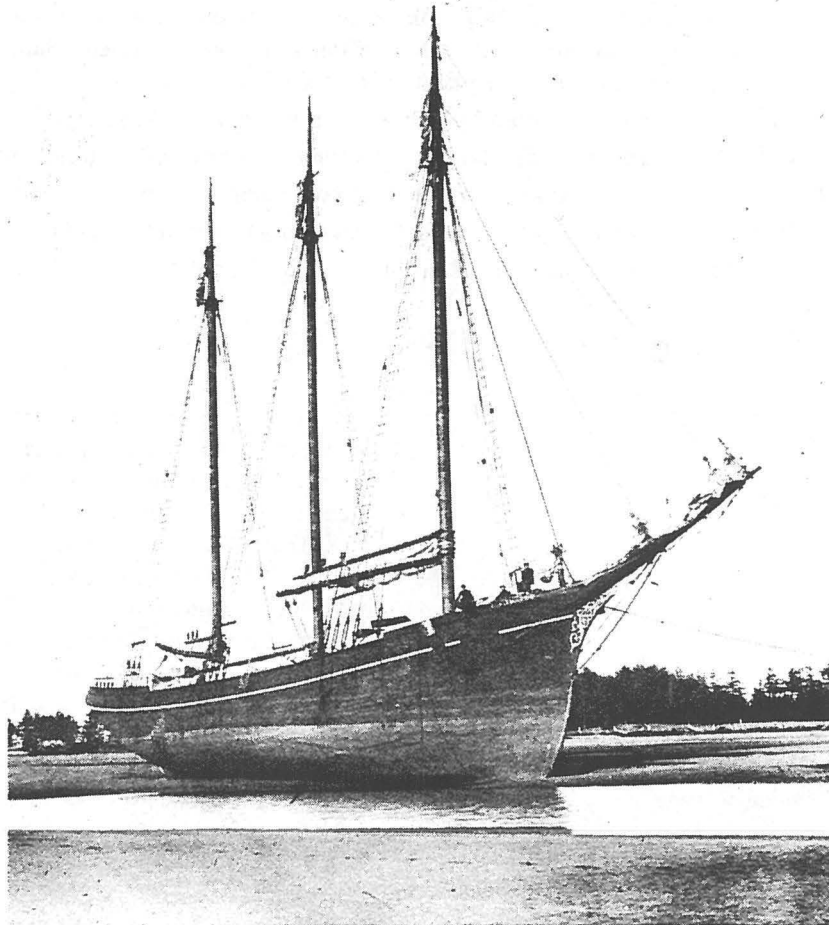
Under the command of Captain Ole Monsen, *C.A. Thayer* went ashore on the North Spit of Gray's Harbor on 8 November 1903. She was refloated by 2 December however, with damage limited to the loss of her rudder, rudderpost, and both anchors. (*Marine Exchange* 1903) Her crew of eight men were taken

Fig. 1. *C.A. Thayer* stranded at Gray's Harbor, Oregon, 12 November 1903.

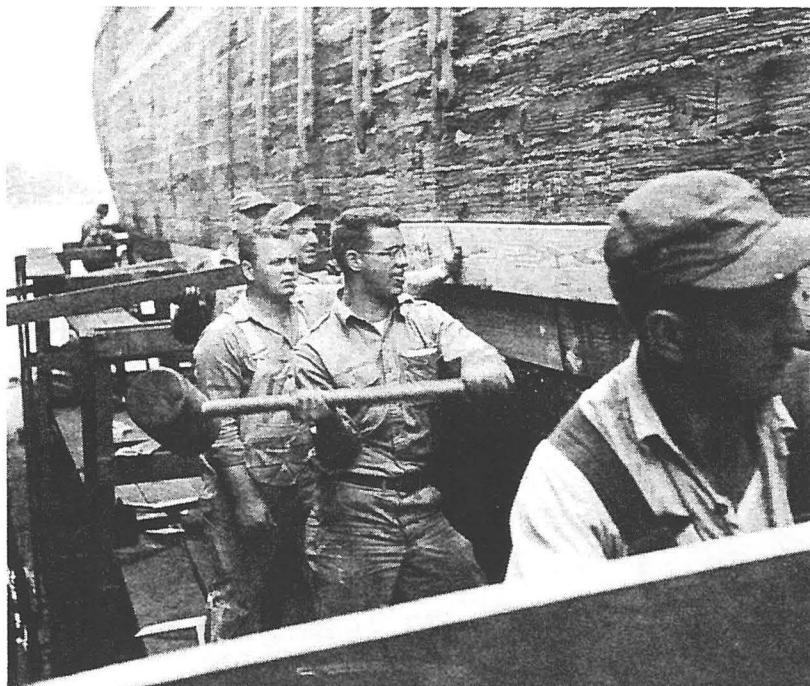
Fig. 9. *C.A. Thayer* undergoing hull plank replacement in Lake Union, Washington, in preparation for her delivery to San Francisco following her purchase by the California Parks Department.

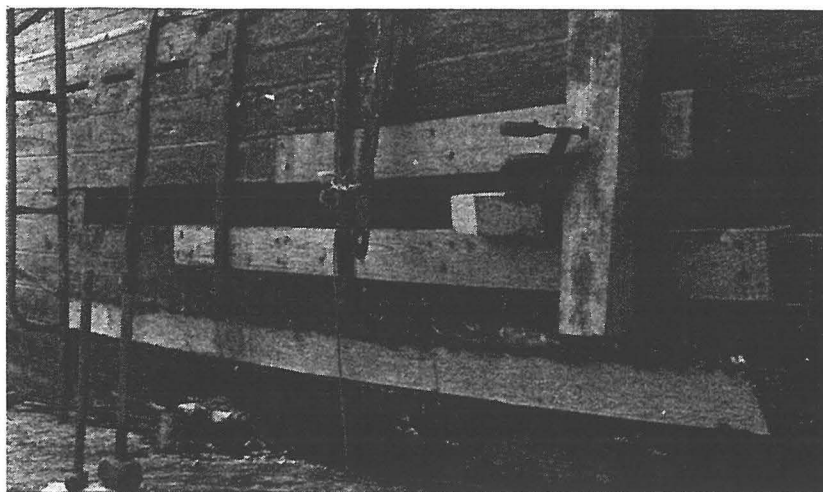
Fig. 14. Renewal of topsides planking, port quarter, frames 47 to 55, part of the preservation work completed in 1987.

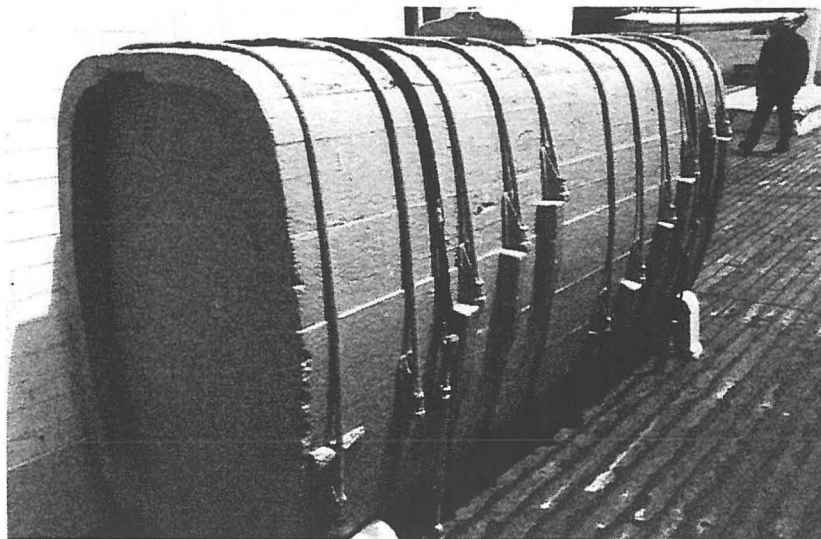
Fig. 23. Wood water tank taken from schooner *Beulah*, on port side of deck-house.

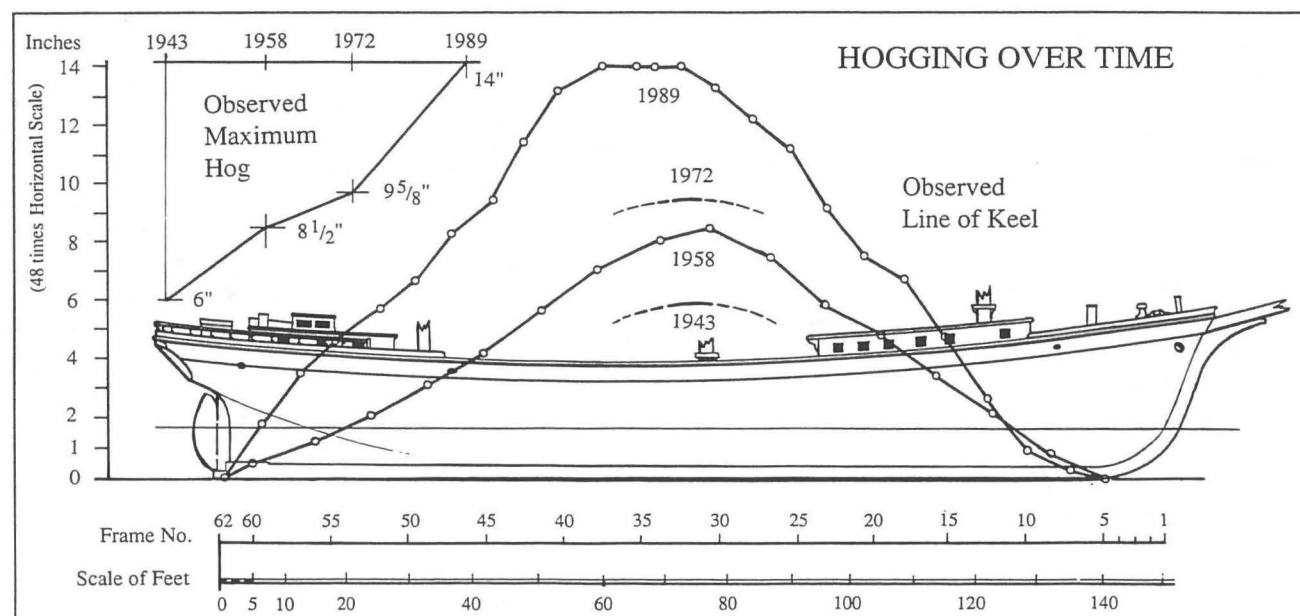
With an empty hold, *C.A. Thayer* has too much buoyancy amidships, a condition that places a structural load on the hull and promotes hogging (an upward arching of the keel). Although hull loading has remained relatively constant over the past forty years, the hull has weakened and succumbed to this force, thus leading to further hogging. Blocking plans from previous drydockings show the hog in *C.A. Thayer's* hull to have increased progressively (see figure 24). Hogging results in hull distortion that is unsightly and difficult to reverse (there are accounts of hog being removed from large wooden vessels, but only by disassembling most of the hull to let the keel settle back to a straight baseline over time).

Fig. 24. Graphic presentation of hogging.

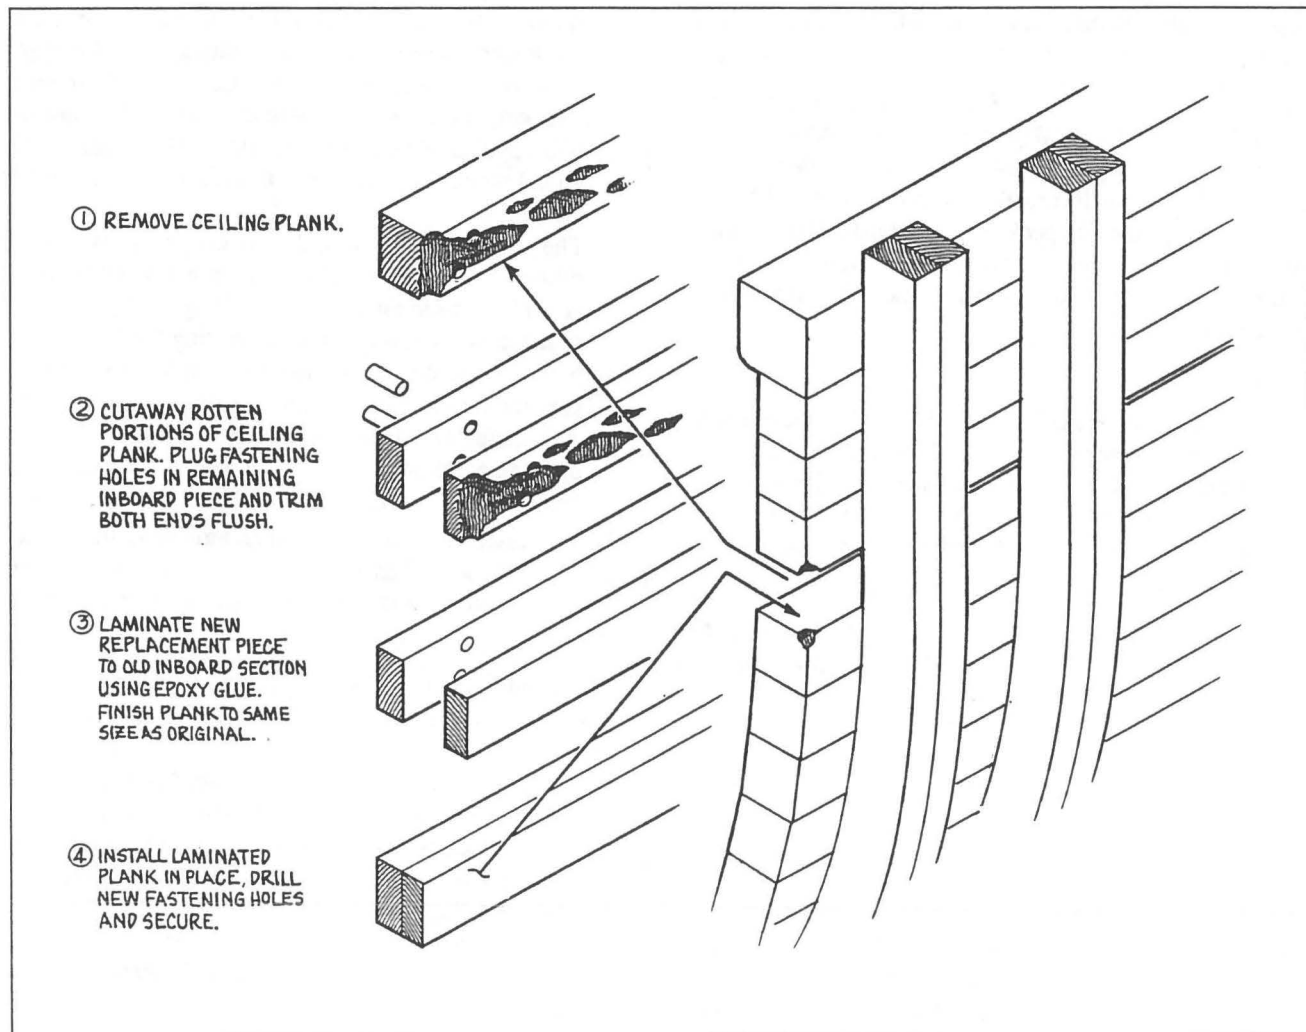
Fig. 25. Ceiling plank reconstruction.

An option for preserving the ceiling by removing each plank and subjecting it to a preservation treatment is illustrated in concept in Figure 25, p. 62. This treatment would restore sufficient strength to the ceiling, while retaining the appearance, but would be labor intensive as it would involve several steps in addition to removal and installation. Furthermore, it may be difficult to remove ceiling planks without irreparably damaging them, particularly if they are found to be extensively edge-fastened. If some of the planks cannot be preserved, the effect would be a patchwork of old and new planking, a result that would not be worth the effort. The workability of this option cannot be determined until an attempt is made to remove ceiling planks intact.

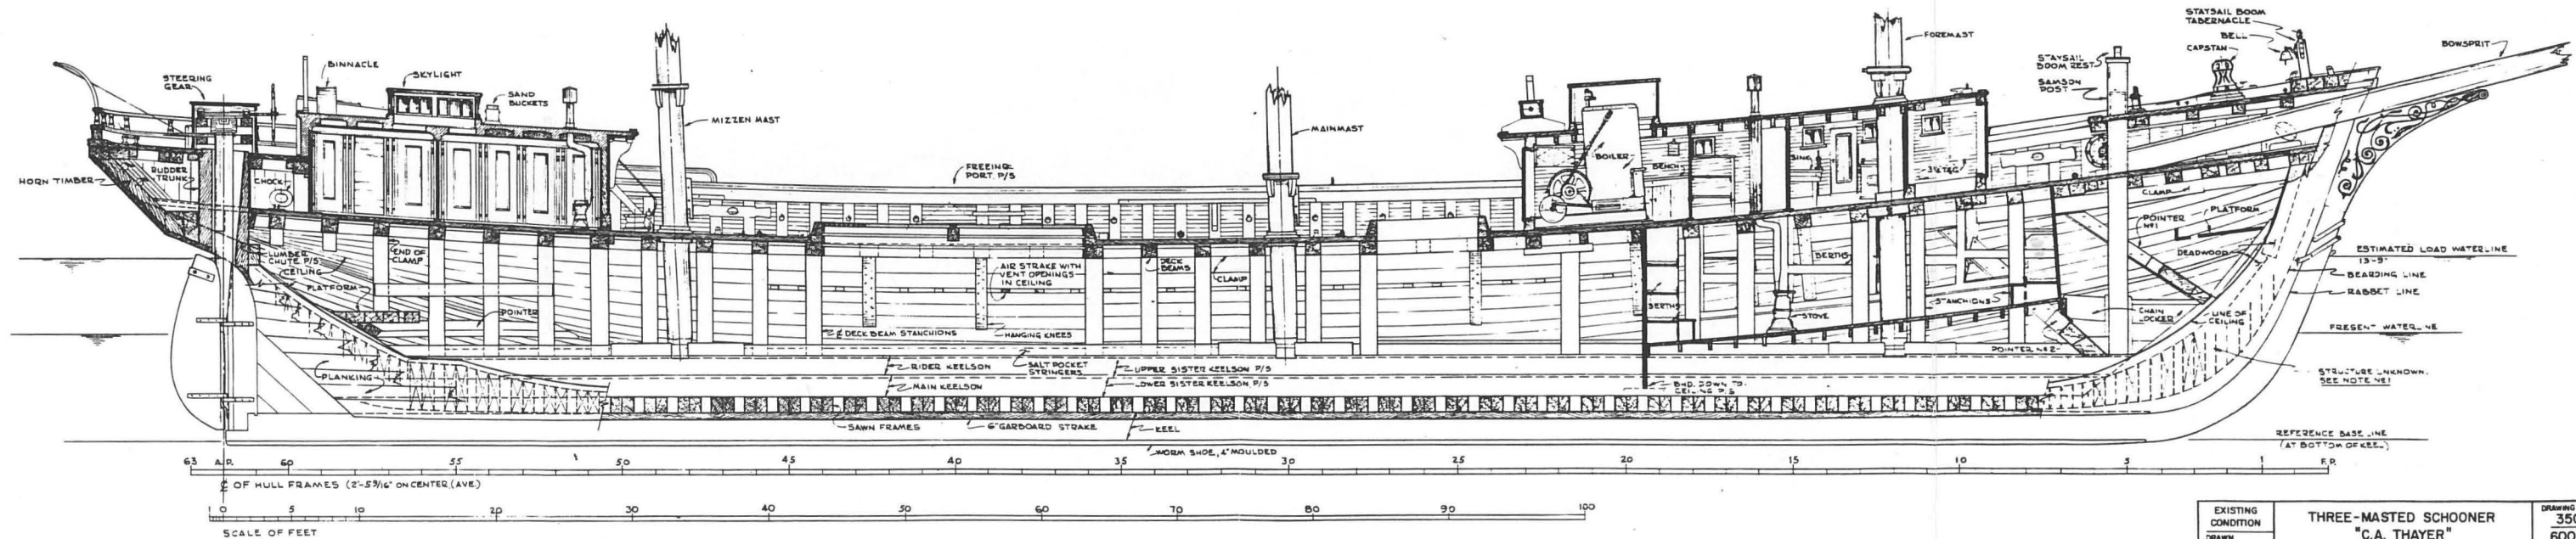
INBOARD PROFILE

1. INTERNAL HULL STRUCTURE AT THE BOW AND STERN HAS NOT BEEN DOCUMENTED DUE TO LACK OF ACCESS. ARRANGEMENT AND DIMENSIONS GIVEN ARE ARE APPROXIMATE ONLY.
2. VESSEL IS SHOWN WITHOUT EXISTING HOG. HOG HAS BEEN MEASURED AT 14" (DEC., 1968) WITH MAXIMUM HOG AT FRAME 34.
